Silicon identification

This errata sheet applies to revision '4' of the STMicroelectronics STM32L475xx products. The STM32L475xx family features an ARM® 32-bit Cortex®-M4 core.

Table 1. Device identification⁽¹⁾

Sales type	Revision code marked on the device ⁽²⁾
STM32L475xx	'4'

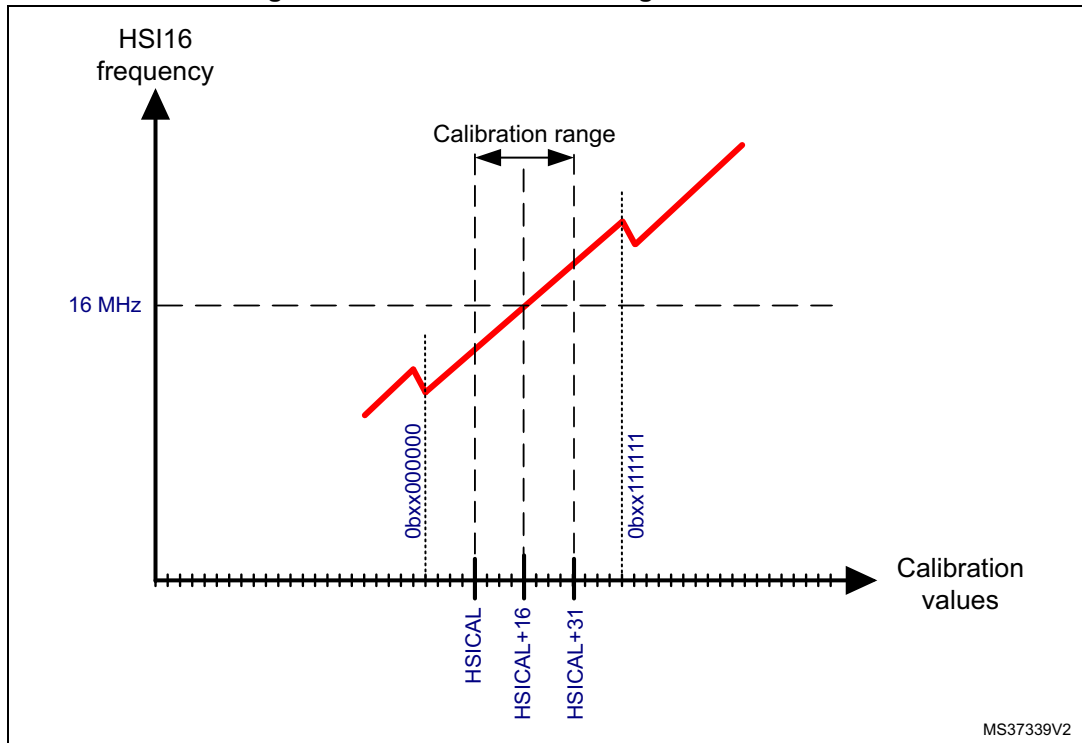
Figure 1. HSI oscillator trimming characteristics

2.1.6 HSI user trim is limited on some samples**Description**

The HSI user trimming step is typically:

- +0.3% of frequency when the trimming code is not a multiple of 64;
- -7% of frequency when the trimming code is a multiple of 64.

As shown in [Figure 1](#), the HSI user trimming allows to add or to subtract up to 16 steps compared to the factory trim value.

If the HSI factory trim value is close to a multiple of 64, with only 16 steps for positive or for negative correction, it is not possible to compensate the 7% drop when the code is a multiple of 64.

Consequently, the user trim correction must not jump over the codes multiple of 64, which can limit the user correction either in positive or in negative direction.

Workaround

None.

Fix

This limitation is fixed on Rev 4 products with date code newer than 609.

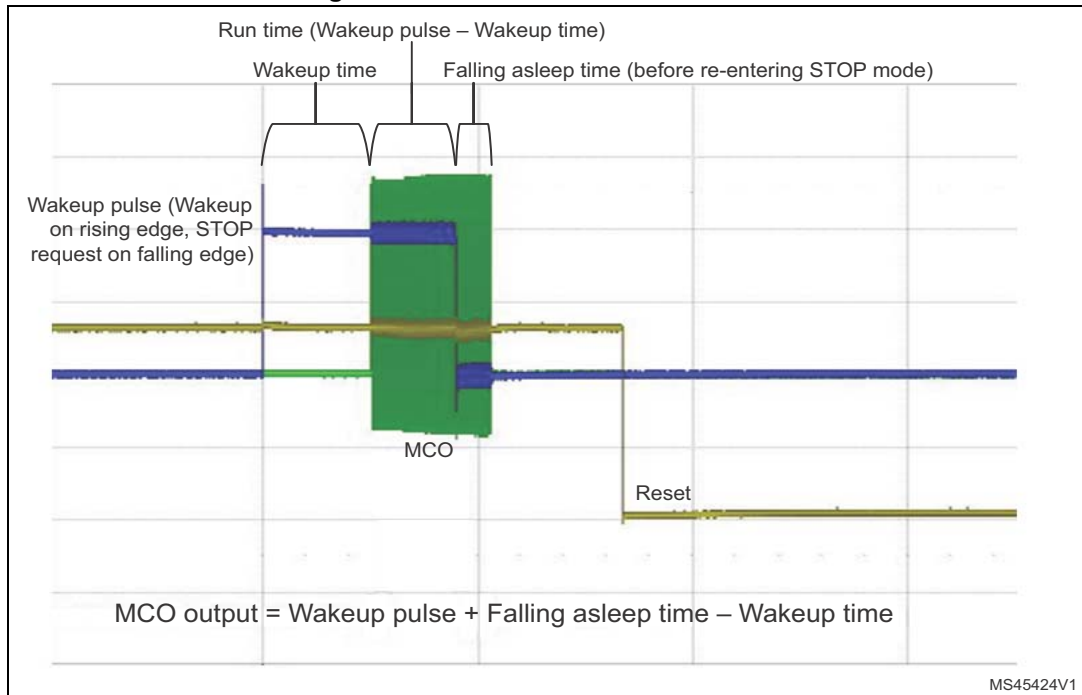
Figure 2. Minimum Run time definition

The minimum Run time defined in [Table 5](#) corresponds to the firmware execution time on the core. Note also that, as shown in [Figure 2](#), the length of the MCO output (green trace) is longer than the firmware execution time.

Workaround

Ensure that the Run time between two Stop sequences is long enough to avoid the generation of a Brown Out Reset.
